**the BIG  
Biodiversity  
Challenge**  
*do one thing*

**(Curry Moor Flood Storage Area)  
(Curry Moor nr Taunton, Somerset)  
(Environment Agency, Atkins, Conservation K9 Consultancy)**

## BIG Biodiversity Challenge Award Category: *Innovation*

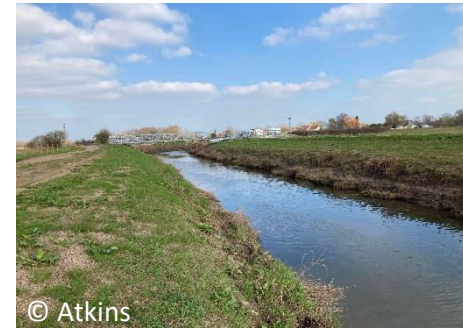
*This section of the River Tone featured steep mud banks that could not be accessed on foot, and had high levels of mink activity, which made finding water vole evidence a challenge.*

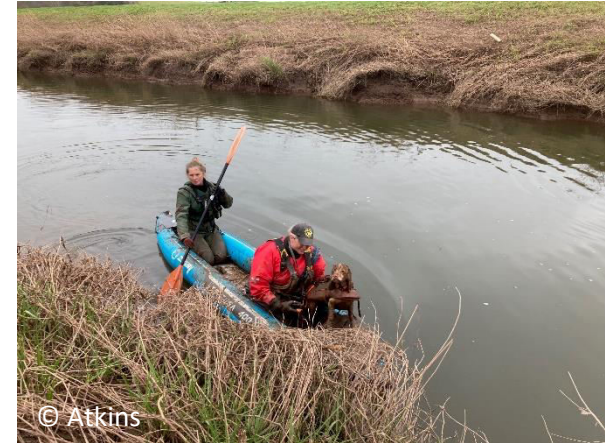
*CK9C's water vole detection team can access the toe of the bank with ease and have a good view of any burrows in the banks*

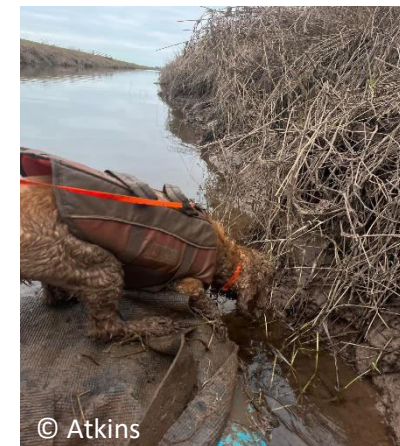
*Hettie working the toe of the bank searching for evidence, she indicates to her handler when water vole evidence is found and gets a reward if water vole evidence has correctly been identified*

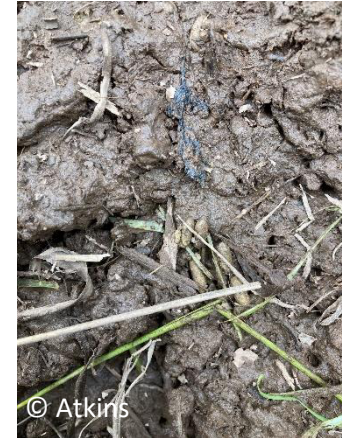
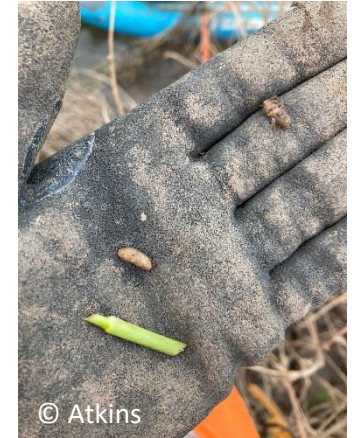
*Water vole field signs found by Hettie on the toe of the bank, concealed by vegetation that would not otherwise have been found*
